MICROSCOPIC EXAMINATION OF STEEL

HENRY FAY, Ph. D., D. Sc.

*Professor of Analytical Chemistry, Massachusetts Institute of Technology
Consulting Metallurgist, Watertown Arsenal*

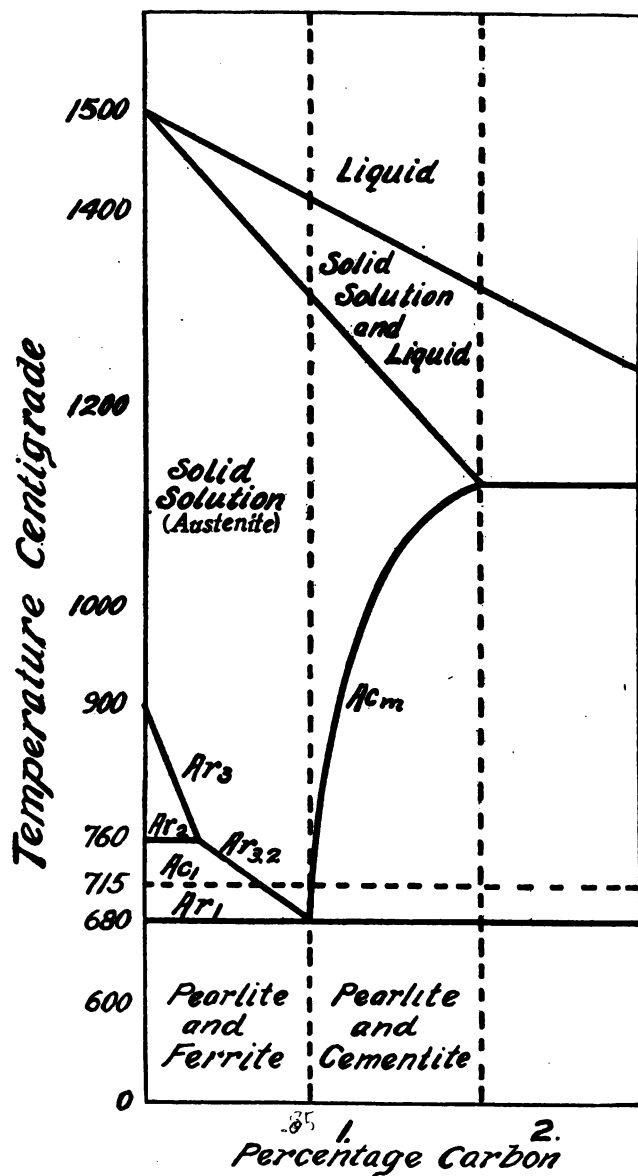
Fig. 1

Portion of iron-carbon diagram

constituents, iron and iron carbide. The Ac_1 point is approximately 30° higher than the Ar_1 point, and represents the beginning of the formation of solid solution. In steels containing 0.85 per cent carbon there is but one critical temperature at which the solid solution decomposes into its constituents, iron and iron carbide. This is known as an eutectoid steel, and its microscopic constituent is pearlite. Pearlite always etches dark, and under high magnifications is shown to consist of alternate laminations of iron and iron carbide. Steels containing less than 0.85 per cent carbon are hypoeutectoid, and contain the microscopic constituents ferrite and pearlite, the amount of the latter increasing with the per cent of carbon. Steels containing more than 0.85 per cent carbon are hypereutectoid, and contain the microscopic constituents cementite (iron carbide, Fe_3C) and pearlite. These facts are illustrated in the diagram. (Fig. 1.)

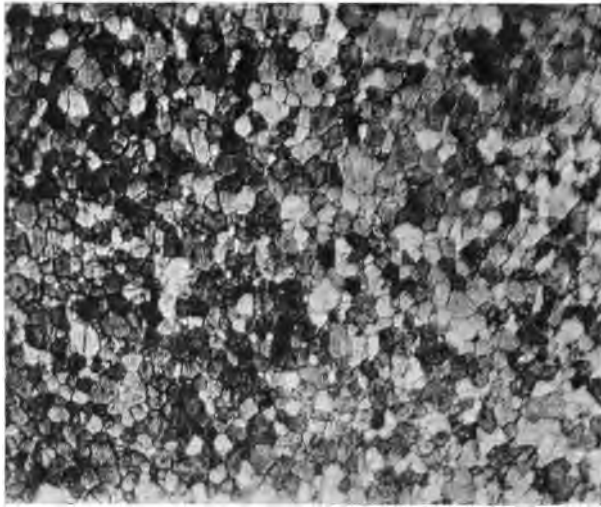
PHOTOGRAPH NO. 1. X75.
0.06% carbon. Approximately pure ferrite.

Photograph No. 1 shows the characteristics of a carbonless iron in which the whole field is made up of granules of ferrite. With the introduction of carbon there is a decrease in the amount of ferrite and the constituent pearlite begins to appear. This is shown in photograph No. 2 for a steel containing 0.18 per cent carbon. Inasmuch as steels containing 0.85 per cent carbon contain 100 per cent pearlite, and as pearlite is composed of ferrite and cementite, in this steel containing 0.18 per cent carbon there ought to be approximately 20 per cent of the field made up of pearlite. In a steel containing 0.5 per cent carbon there should be 58.8 per cent pearlite. Such a steel is shown in photograph No. 4. A eutectoid steel containing 0.83 per cent carbon and practically 100 per cent pearlite is shown in photograph No. 7. Under higher magnifications pearlite shows the laminated structure shown in photograph No. 8. In hypereutectoid steels the excess carbon beyond that necessary to form pearlite, separates as free cementite and the amount of free cementite can be calculated. Inasmuch as the whole field is made up of pearlite

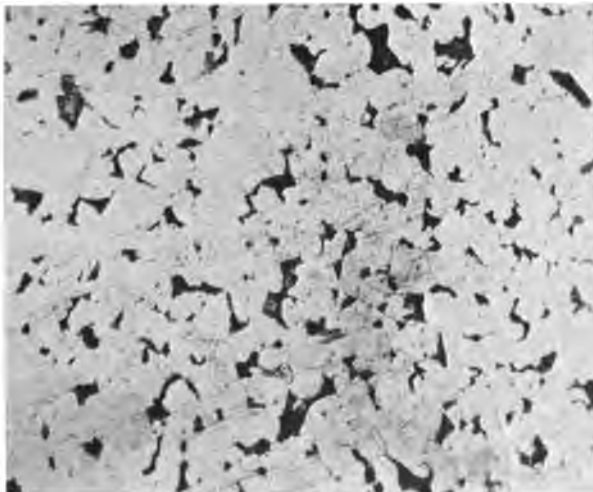
PHOTOGRAPH NO. 2. X75.
0.18% carbon. Ferrite (white) and pearlite (dark).

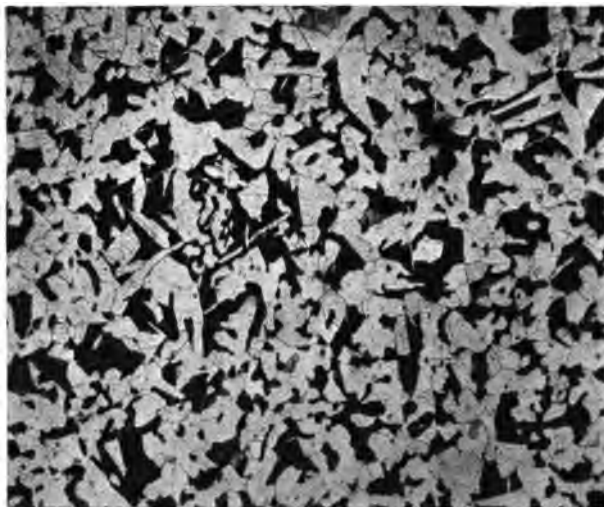
PHOTOGRAPH NO. 3. X75.

0.32% carbon. Ferrite (white) and pearlite (dark).

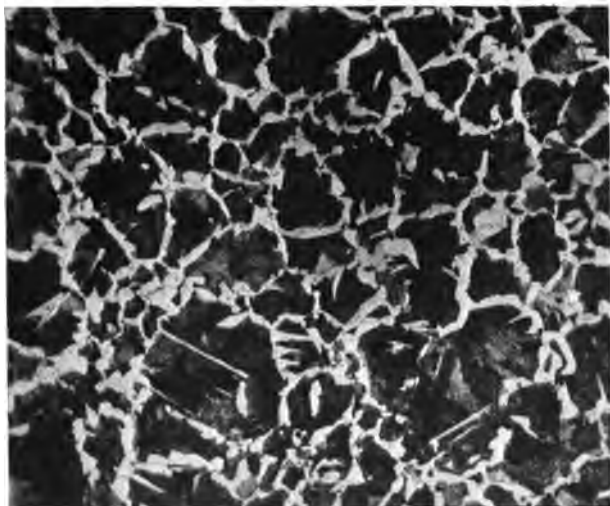
PHOTOGRAPH NO. 4. X75.

0.49% carbon. Ferrite (white) and pearlite (dark).

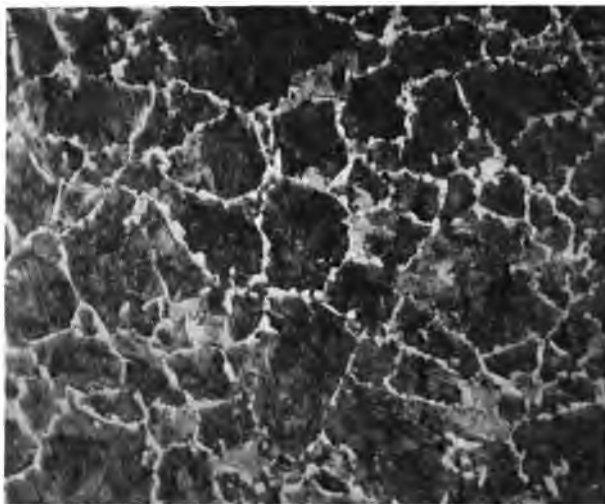
PHOTOGRAPH NO. 5. X75.
0.57% carbon. Ferrite and pearlite.

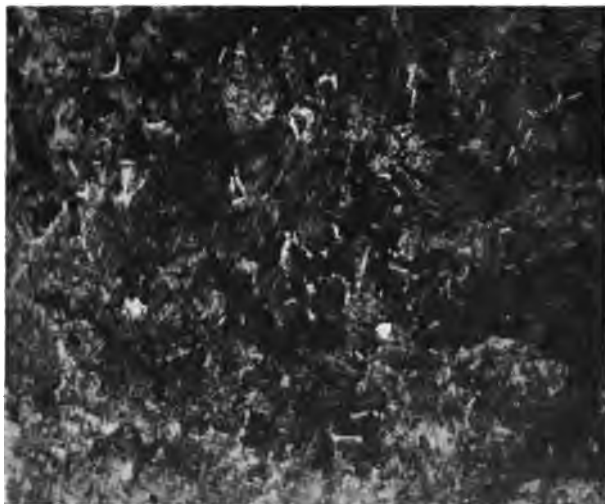
PHOTOGRAPH NO. 6. X75.
0.71% carbon. Ferrite and pearlite.

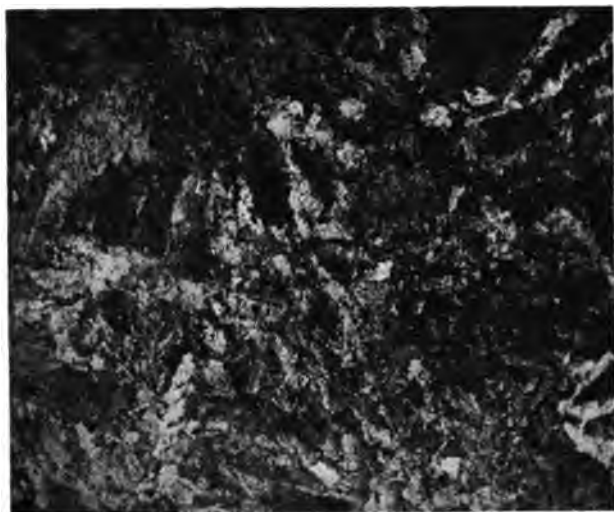
PHOTOGRAPH NO. 7. X75.

0.83% carbon. Pearlite.

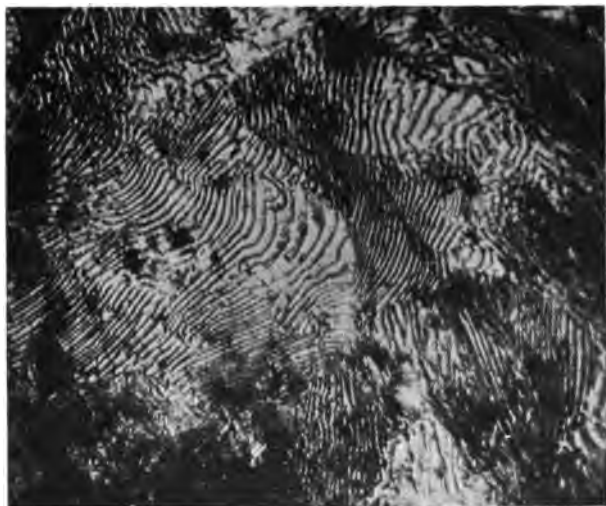
PHOTOGRAPH NO. 8. X485.

0.83% carbon. Pearlite.

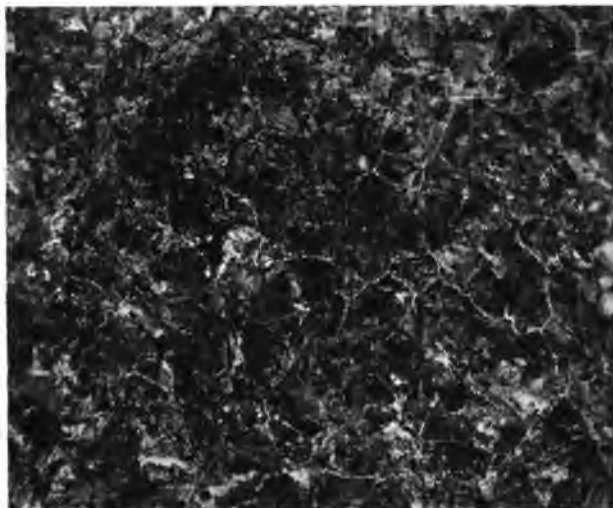
PHOTOGRAPH NO. 9. X75.

1.22% carbon. Pearlite and cementite (white).

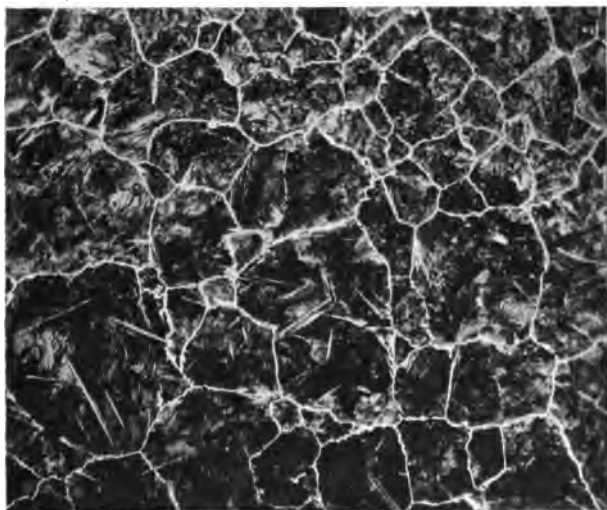
PHOTOGRAPH NO. 10. X75.

1.46% carbon. Pearlite and cementite (white).

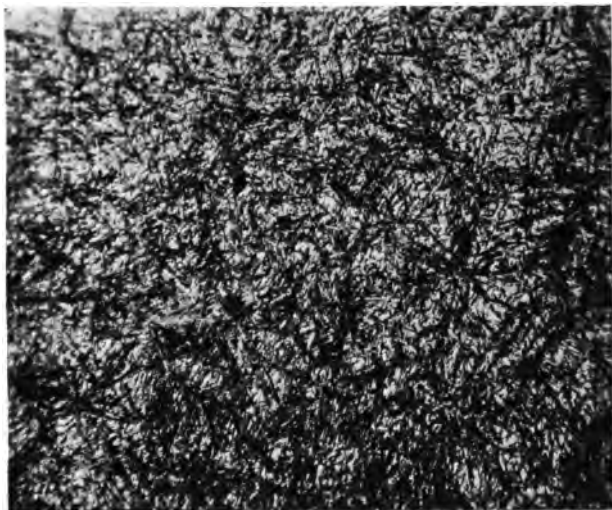
PHOTOGRAPH NO. II. X75.

Martensite.

Photograph No. 11 shows the characteristic appearance. Commercially martensitic steels are unimportant on account of their extreme brittleness and they are found only rarely.

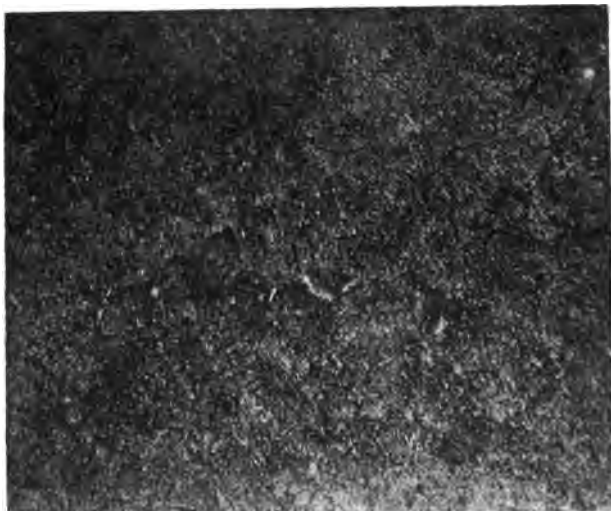
PHOTOGRAPH NO. 12. X75.

Troostite.

observed that the original martensitic structure is completely removed by the tempering process. This point is illustrated by photograph No. 34 in which there are distinct remains of the original martensitic structure. Such a steel properly heat treated ought to show a structure similar to photographs Nos. 12 or 13.

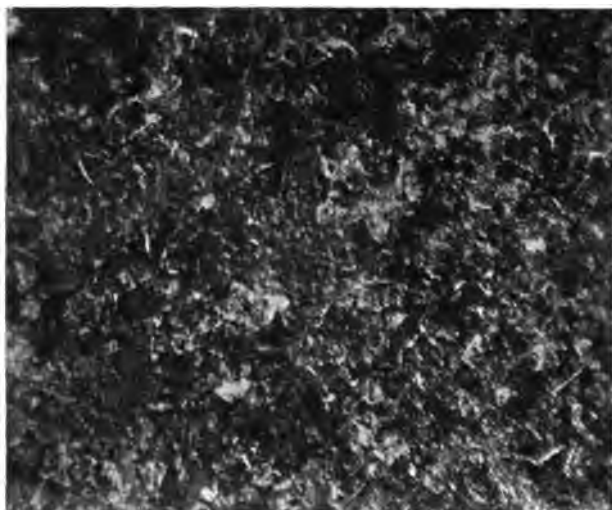
PHOTOGRAPH NO. 13. X75.
Sorbite.

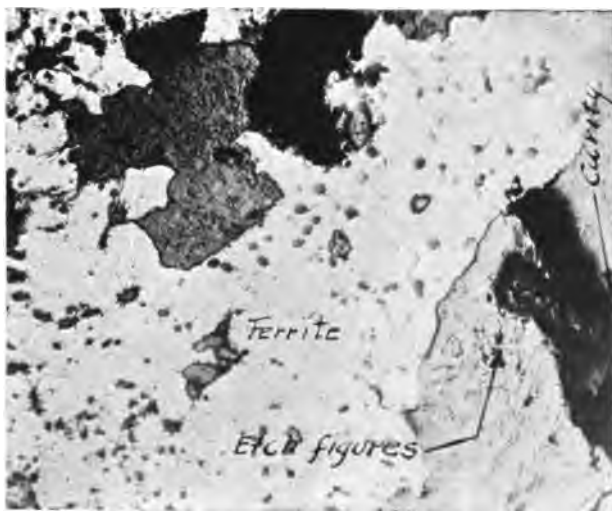
PHOTOGRAPH NO. 14. X50.
Ferrite and massive silicate of manganese. Etch figures in the
silicate. (Ferrite, white; silicate, dark.)

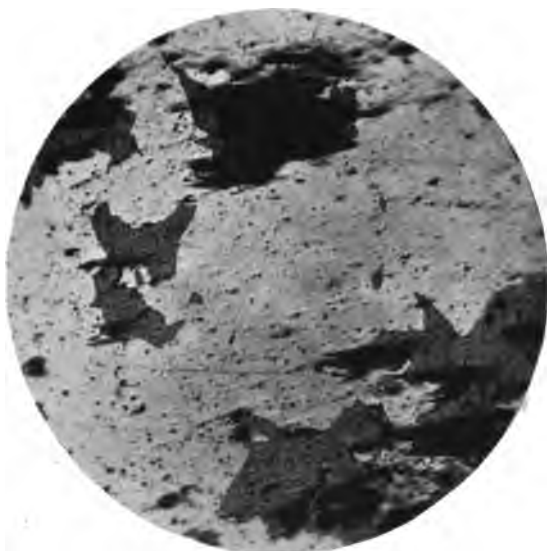
PHOTOGRAPH NO. 15. X50.

Etch figures in silicate of manganese, and cavities due to removal of silicate.

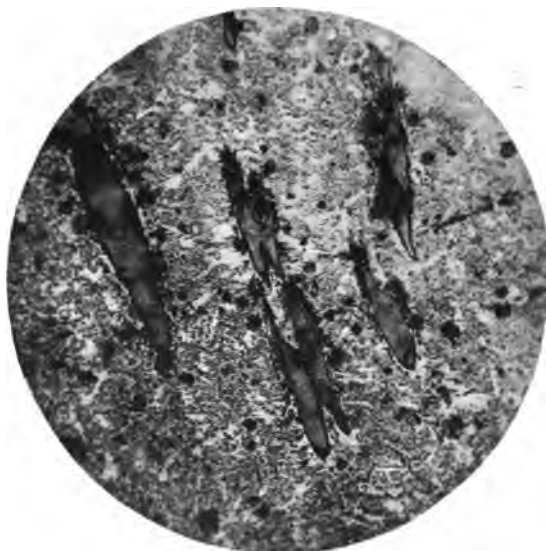
PHOTOGRAPH NO. 16. X50.

Sulphide of manganese in gun steel.

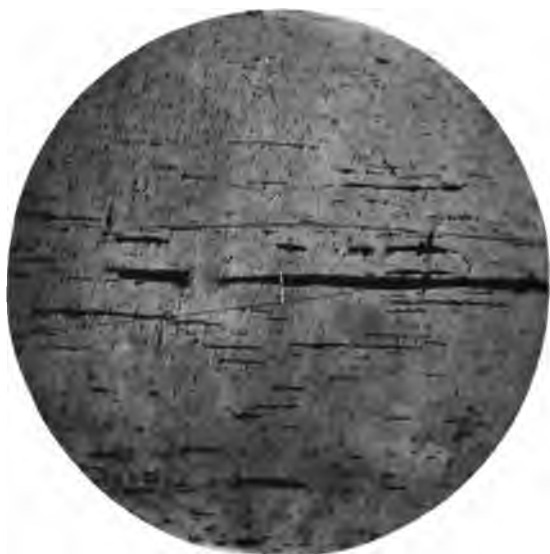
PHOTOGRAPH NO. 17. X50.

Slag elongated in direction of forging. Specimen unetched.

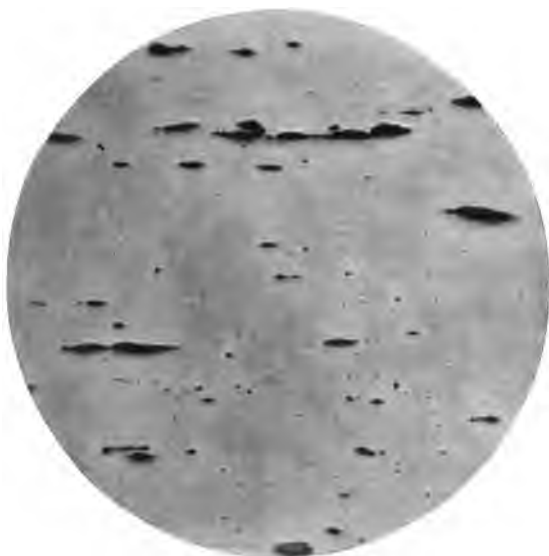
PHOTOGRAPH NO. 18. X50.

Unevenly distributed slag. Specimen unetched.

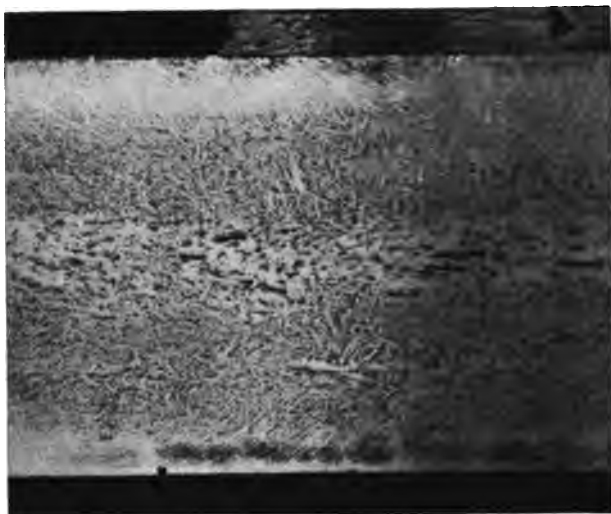
PHOTOGRAPH NO. 19. ONE-THIRD SIZE.
Ingot structure in steel.

The presence of ingot structure such as shown in photograph No. 19 indicates that the heat treatment and forging have not been sufficient to wipe out the crystallization which occurred on the solidification of the metal. It is not definitely known that the presence of ingot structure is harmful, and it is frequently accompanied by excellent microstructure, but it serves as an indication of the heat treatment to which the metal has been subjected after solidification. It is believed that such a structure would not be found in the best steel, and it is further believed that metal showing ingot structure would be more liable to rupture from shock than metal in which the ingot structure had been wiped out by heat treatment and forging.

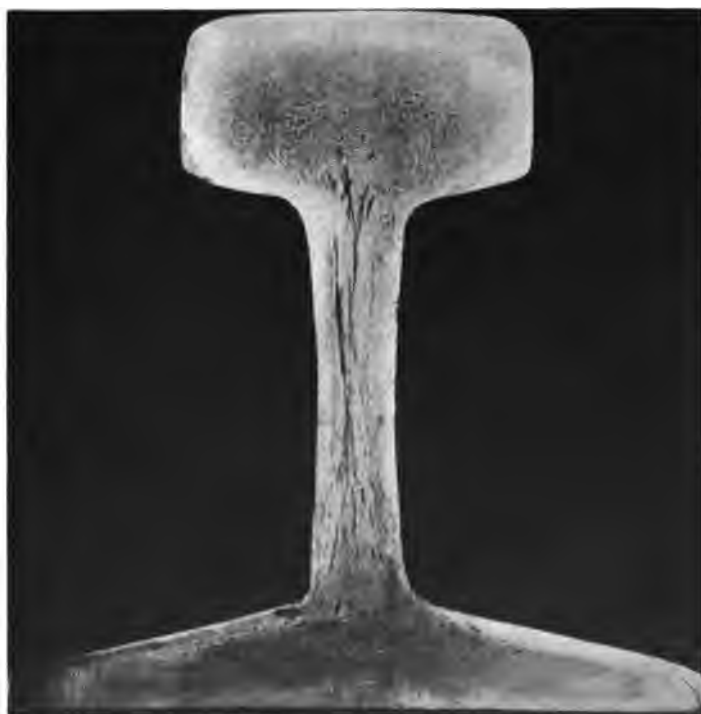
PHOTOGRAPH NO. 20.
Cross section of steel rail showing segregation in center of head, web, and base.

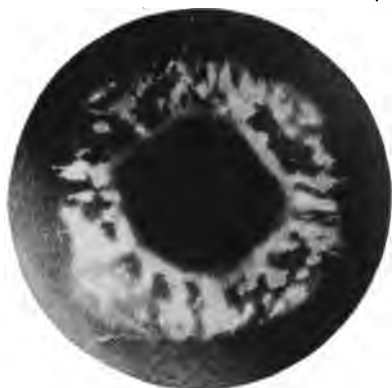
PHOTOGRAPH NO. 21.

**Segregation of phosphorus in cold-rolled shafting.
Etched with iodine. (White areas.)**

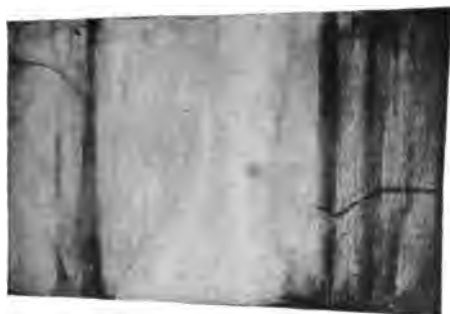
PHOTOGRAPH NO. 22.

**Cross section of No. 21. Etched with nitric acid.
(Dark streaks.)**

in which segregation of phosphorus is shown. Photograph No. 22 shows a longitudinal section of the same piece of shafting and is etched with nitric acid, which darkens the phosphide areas. It is seldom possible, however, to obtain complete cross sections, but valuable indications may be obtained from surface structures or from test-bar sections, such as shown in photograph No. 38 of test bars marked 2, 3, and 5. The phenomena observed here will be more fully discussed later.

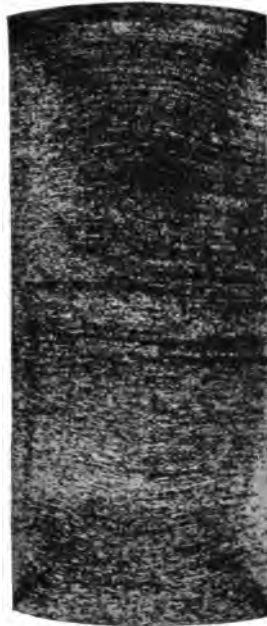
PHOTOGRAPH NO. 23.

Area of strained metal brought out by etching with copper ammonium chloride.

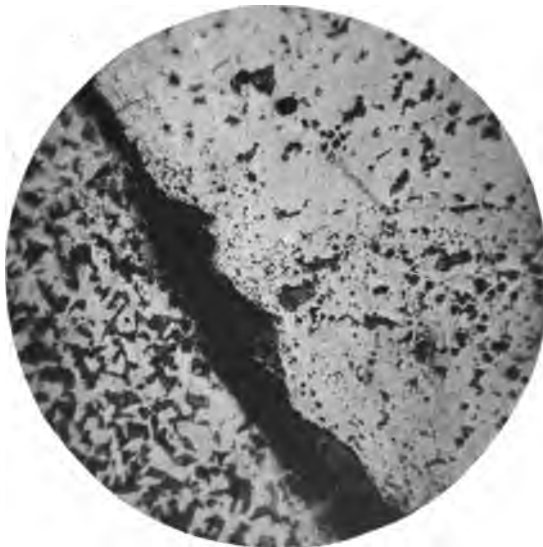
PHOTOGRAPH NO. 24. X50.

Crack, slag, and decarbonized area found on the base of a steel rail.

The inclusion of oxide is frequently accompanied by partial decarbonization, and is most frequently found on or near the surface. An example of this is shown in photograph No. 24, in which it is seen that a crack has penetrated through the slag, probably mill scale, and in the crack are the remnants of the slag. On the left of the crack is the normal structure and on the right is a decarbonized area containing slag. Such an area would probably be large enough to show to the naked eye and would be considered unsafe. Other examples of oxide inclosures are cited on pages 14 and 15, in the discussion of the failure of 10-inch gun and 14-inch gun lever.

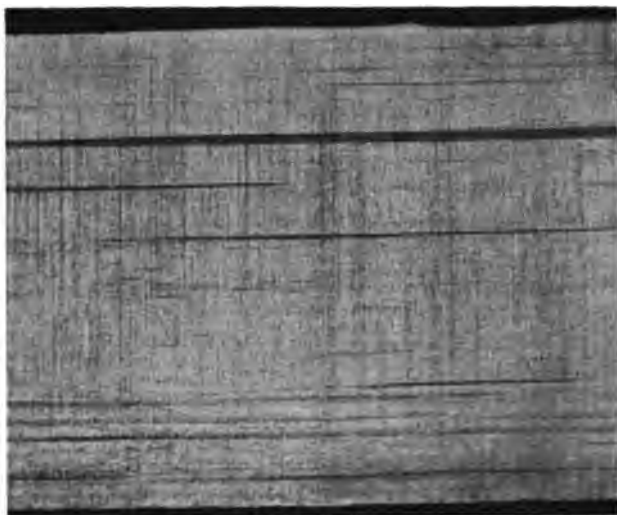
PHOTOGRAPH NO. 25.
Dark streaks in steel rail.

Radial test pieces from gun forgings will frequently show streaks, and as the tension is normal to the direction of extension the specimen will show low ductility. Photographs Nos. 25 and 26 show, respectively, dark and light streaks, and photograph No. 27 shows the microstructure of a portion of the light-colored streak with its decarbonization and accompanying slag. (See also Tests of Metals for 1909, vol. 11.)

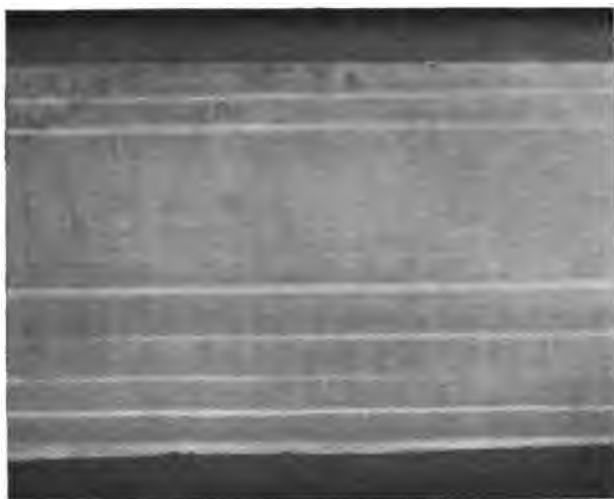
PHOTOGRAPH NO. 26.
Light streaks in steel rail.

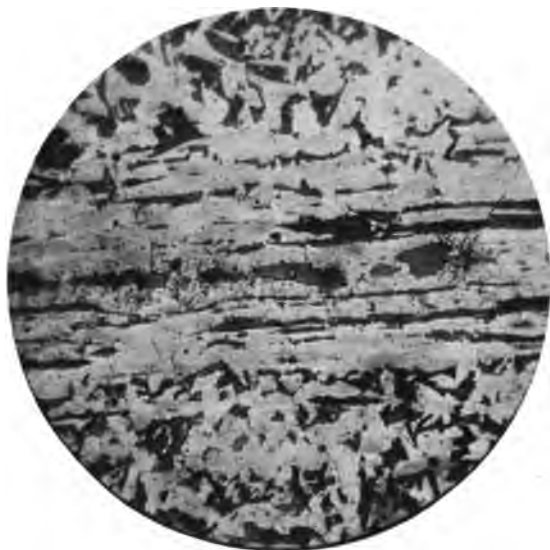
PHOTOGRAPH NO. 27. X50.

Microstructure of light-colored streak in No. 26.

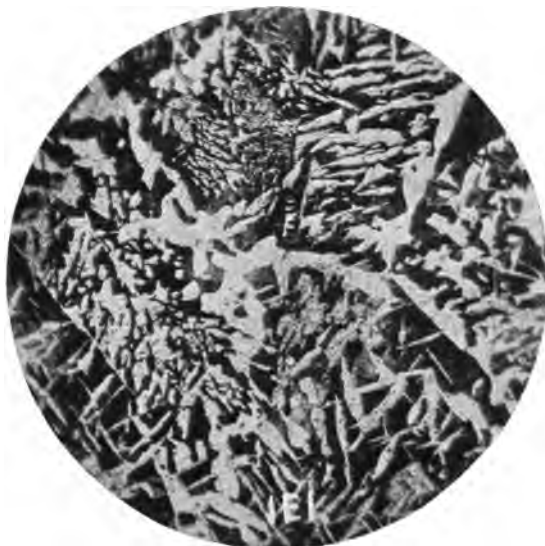
PHOTOGRAPH NO. 28. X75.

Microstructure of cast steel ingot as cast.

Elastic Limit	39,000
Tensile Strength	77,000
Elongation	10.5
Contraction of Area	16.9

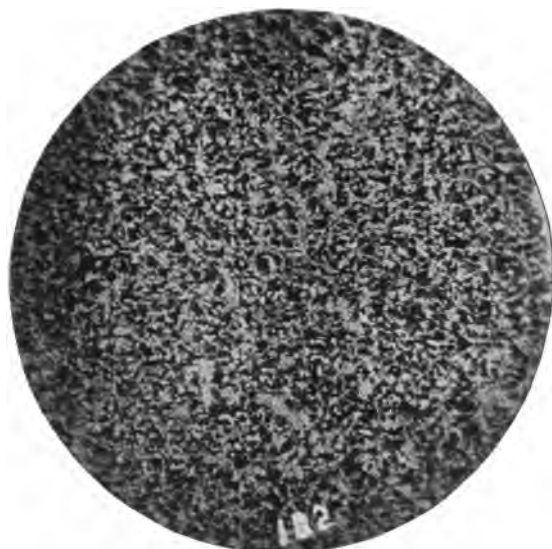
PHOTOGRAPH NO. 29. X75.

Microstructure of cast steel ingot forged to 1450° F. (788° C.)

Elastic Limit	50,500
Tensile Strength	83,500
Elongation	27.5
Contraction of Area	43.3

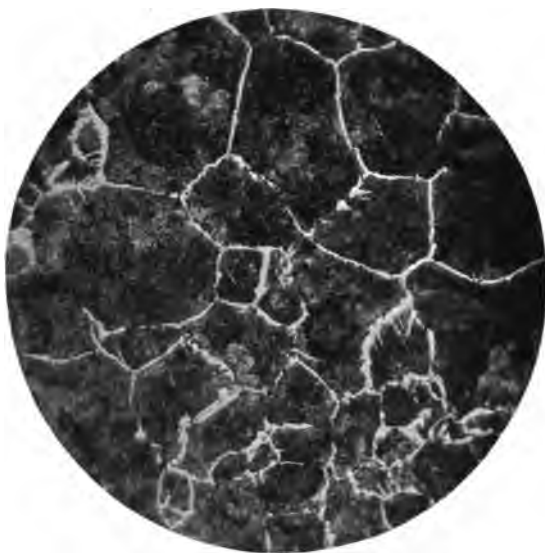
PHOTOGRAPH NO. 30. X75.
Coarse microstructure in gun steel.

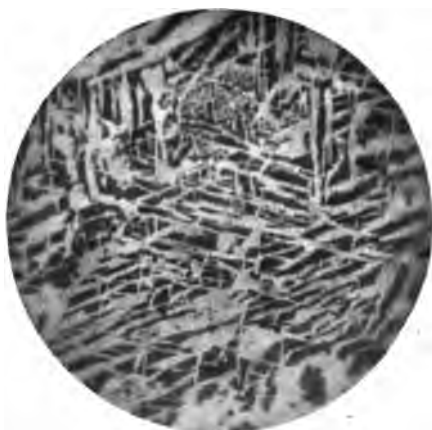
PHOTOGRAPH NO. 31. X50.
Crystalline structure in cast steel.

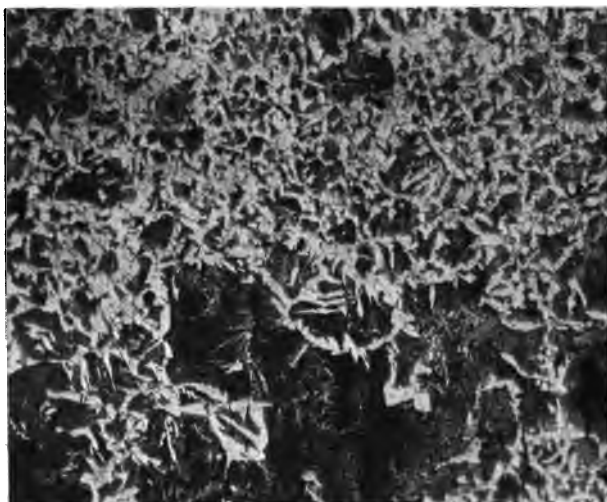
PHOTOGRAPH NO. 32. X75.
Microstructure showing incomplete heat treatment.

Failure to obtain uniformity of structure is shown in photograph No. 32. Discussion of photographs Nos. 49, 51, and 53 will be found under the discussion of some of the special cases, viz., the failure of 14-inch gun lever arm. Dangerous overheating is shown in photograph No. 33. In this case the material is burnt, as is shown by the oxide between the granules of pearlite.

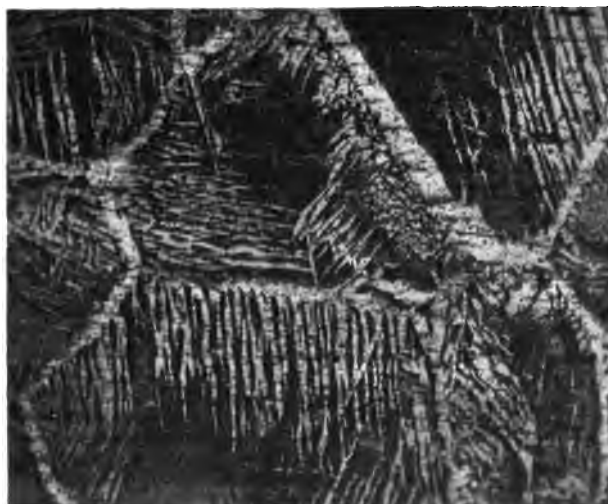
PHOTOGRAPH NO. 33. X75.
Microstructure of overheated steel.

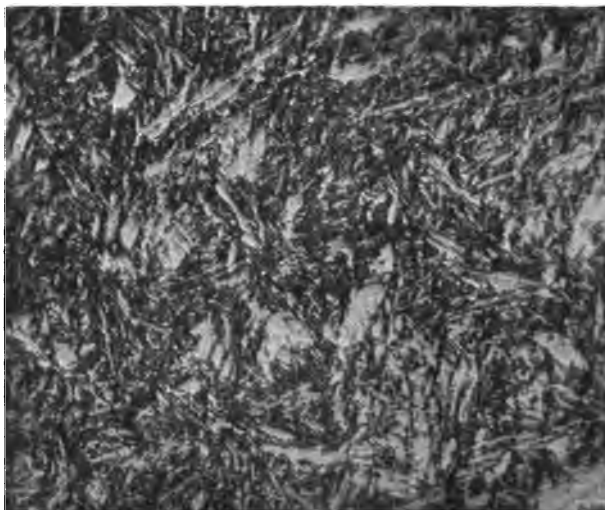
PHOTOGRAPH NO. 34. X500.

Microstructure of forging which had been originally martensitic, and in tempering this structure has not been completely eliminated.

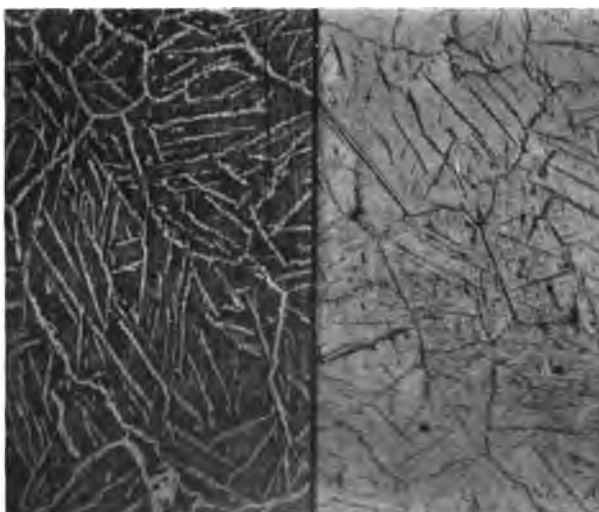
PHOTOGRAPH NO. 35. X65.

Microstructure in center of broken recoil spring showing excess cementite, indicating high carbon. Left, white lines are cementite etched with nitric acid solution; right, dark lines are cementite etched with sodium plorate solution.

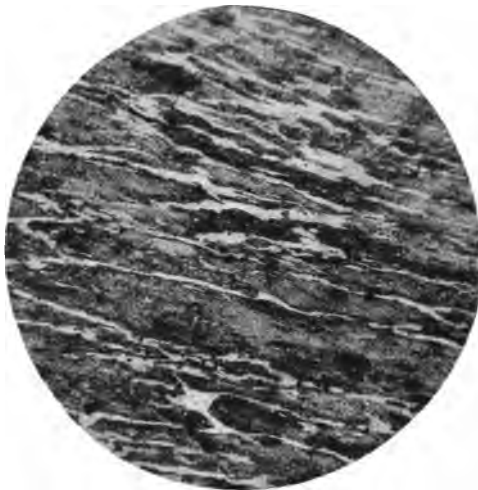
PHOTOGRAPH NO. 38. X50.

**Microstructure of steel subjected to cold work, and
showing distortion of grain.**

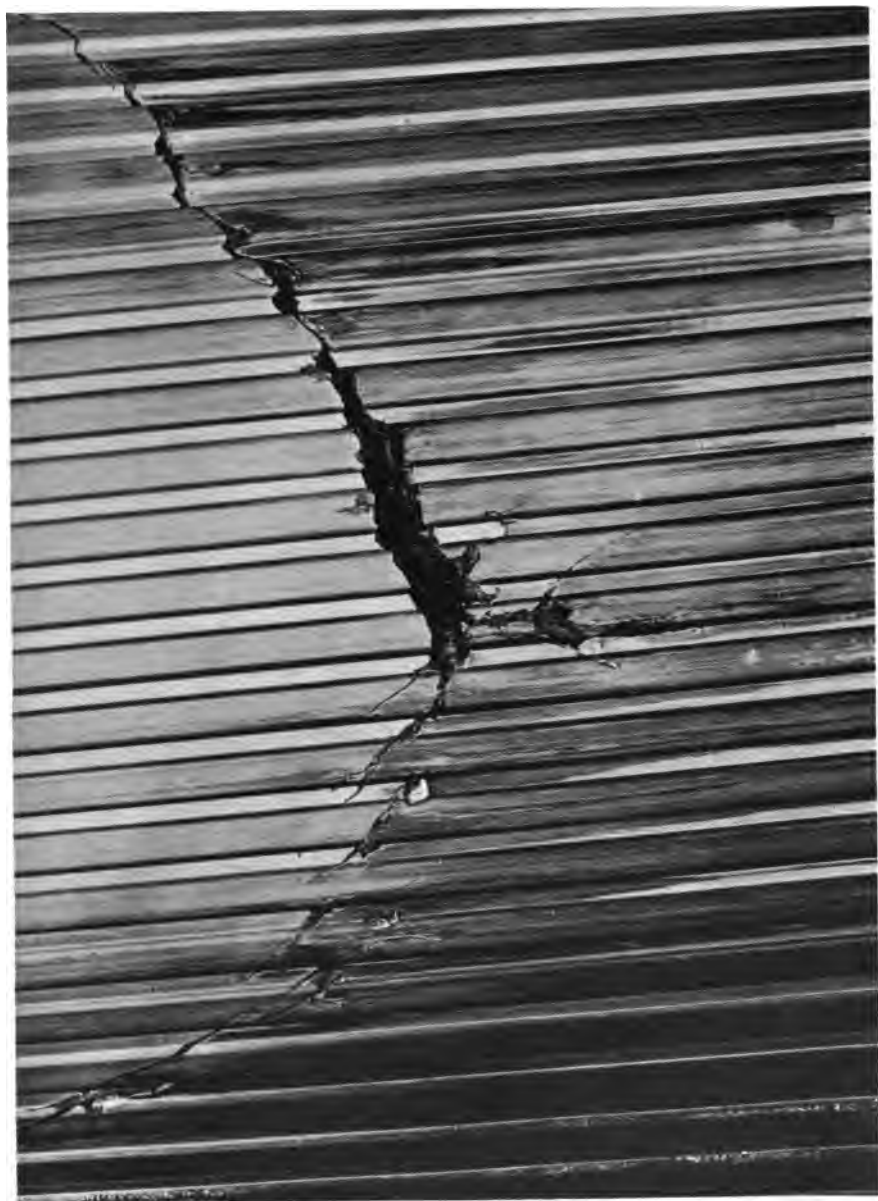
PHOTOGRAPH NO. 37.
Crack in 10-inch rifle.

The tube of this gun was found to be cracked after proof-firing. The crack was situated about 2 feet in from the breech end and extended in the form of a crescent through a visible distance of about 10 inches. At the central portion of the crack the walls were considerably more separated than at either end, and considerable metal had been removed at this point. The general appearance is shown in photograph No. 37. It will be noted that the crack is not continuous.

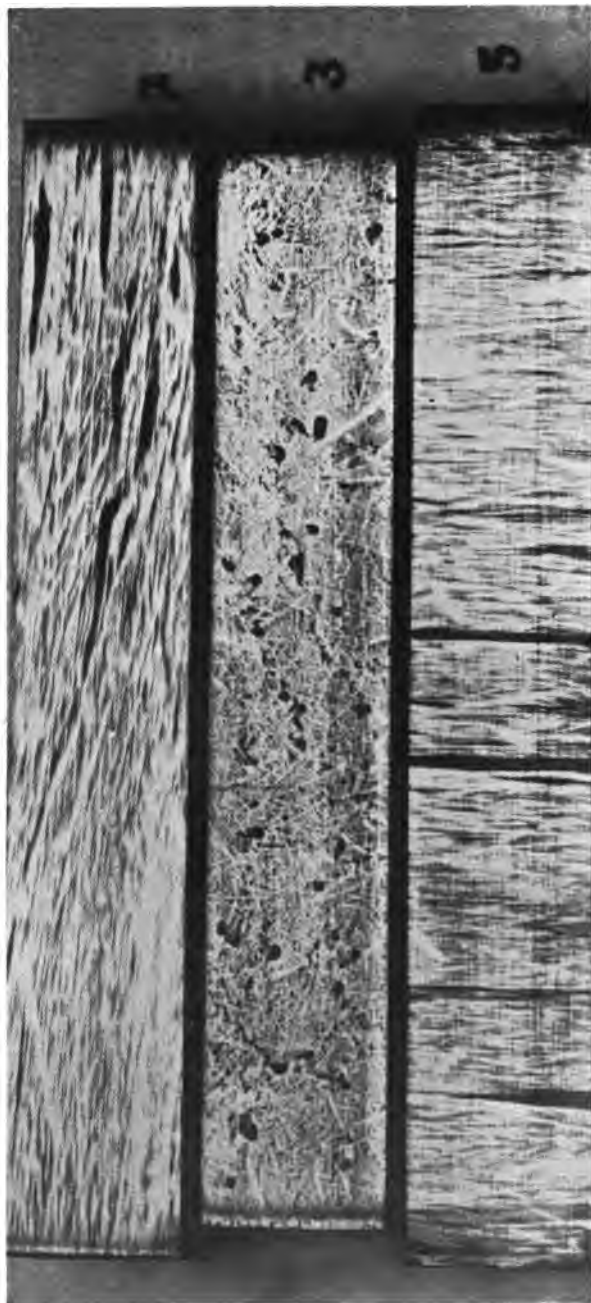
PHOTOGRAPH NO. 38.

Macrostructure of test bars of 10-inch rifle, showing surfaces cut longitudinal (5), radial (3), and tangential (2) to axis.

Photographs Nos. 38 and 39 show the macrostructure of this steel when etched with iodine, the specimens shown in photograph No. 38 being taken longitudinally, radially, and tangentially. The segregation of phosphorus is indicated by the dark lines in pieces Nos. 2 and 5 of photograph No. 38 and in both pieces of photograph No. 39 and by the dark spots in piece No. 3. Photograph No. 39 shows the metal cut from the region of the fracture and treated in the same manner, as shown in test piece marked 5 in photograph No. 38, and in other test pieces not shown. The dark streaks were found to be elongated parallel to the direction of forging, and it is reasonable to suppose that the elongation will always be parallel to the surfaces being forged. By inspection of the two larger pieces of metal cut from the region of the crack (photograph No. 39) it will be seen that there is considerable distortion of the phosphide areas near the

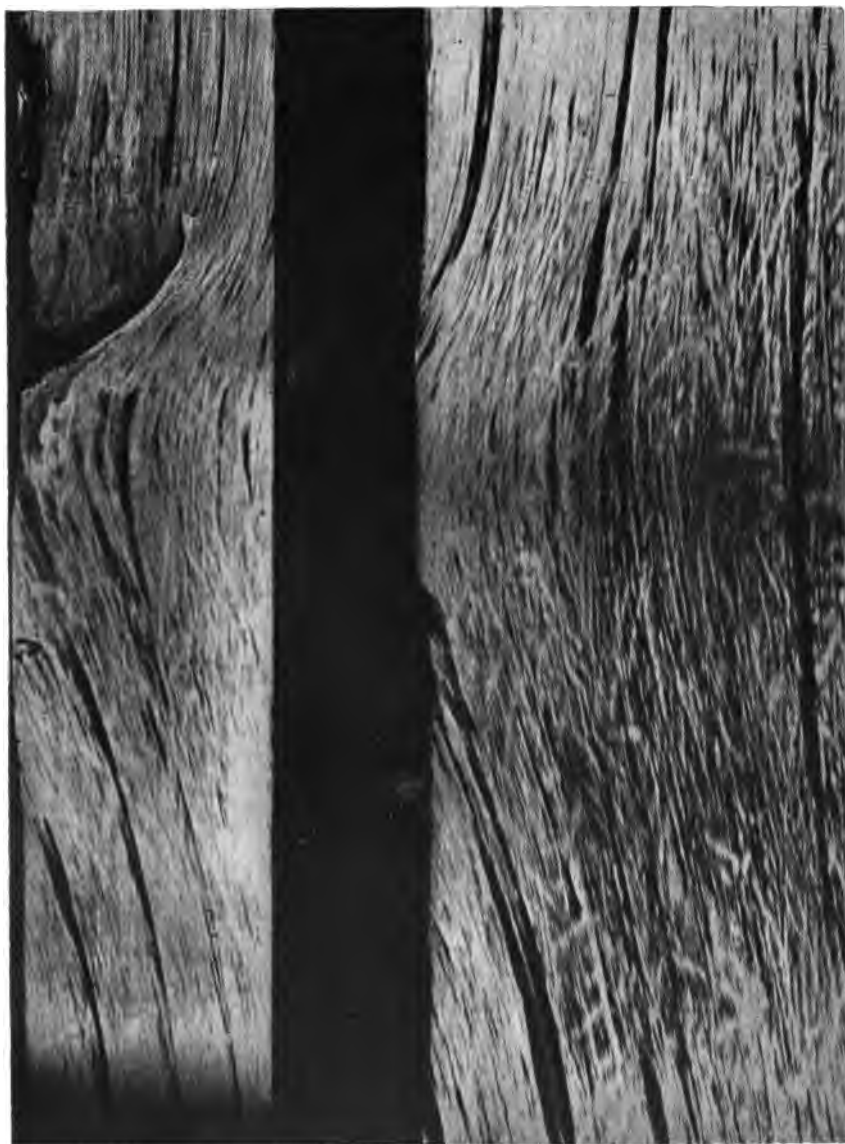
PHOTOGRAPH NO. 38.
Macrostructure in region of crack in 10-inch rifle.

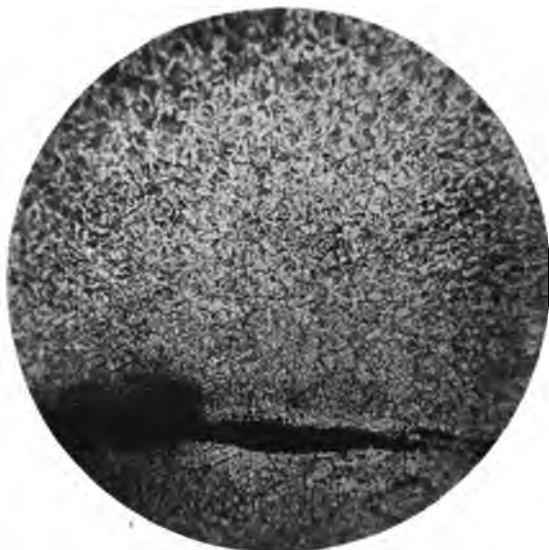
PHOTOGRAPH NO. 40. X50.

Crack and slag, with decarbonized area in 10-inch rifle.

Examination of sections in the vicinity of the crack showed many fine cracks, slag inclusions, and carbonless areas. The cracks led to slag, and where the slag was found there were also found decarbonized areas. Photograph No. 40 shows a crack ending in slag and surrounded by decarbonized iron. The course of the slag was quite irregular, as shown in photographs Nos. 41 and 42.

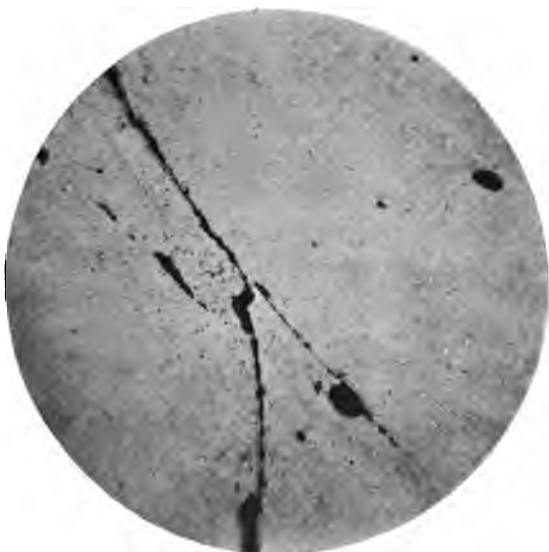
PHOTOGRAPH NO. 41. X50.

Slag in 10-inch rifle, unetched.

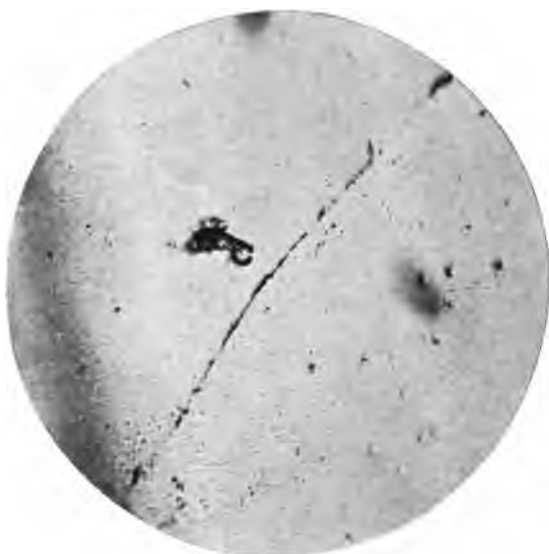
PHOTOGRAPH NO. 42. X50.

Slag in 10-inch rifle, unetched.

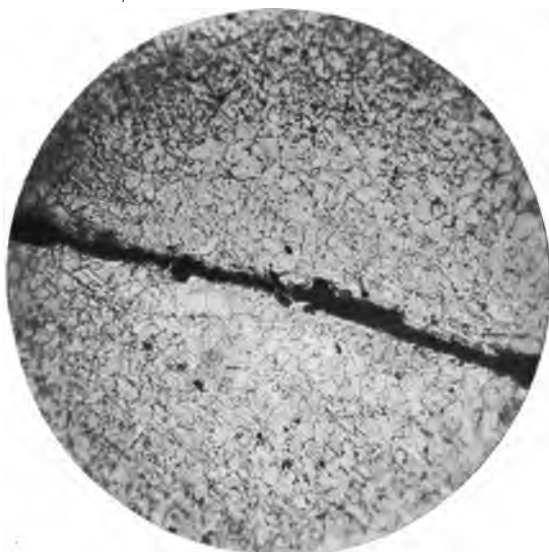
PHOTOGRAPH NO. 43. X50.

Slag and decarbonized area in 10-inch rifle.

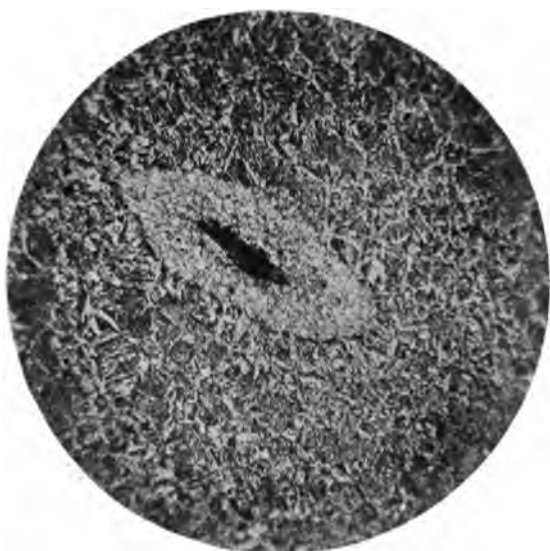
PHOTOGRAPH NO. 44. X50.

Island of slag in decarbonized area in 10-inch rifle.

That the slag originated and was folded into the metal during the process of forging rather than during the manufacture of the steel is indicated by the fact that it is strongly oxidizing in character. If it had originated at the time of making the steel, and had then burned out some of the carbon, there would still have been plenty of time for more carbon to have diffused back into these areas. It is found here, however, surrounded by free ferrite along the slag lines, as shown in photograph No. 43 and in photograph No. 44, in which is shown an isolated slag spot surrounded by free ferrite, and this in turn by the normal structure.

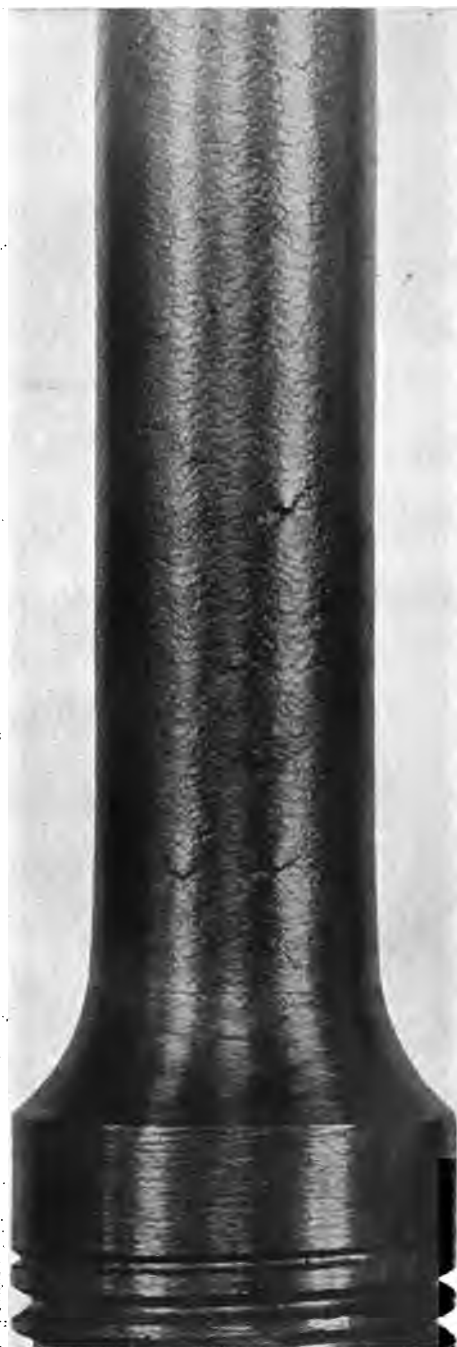
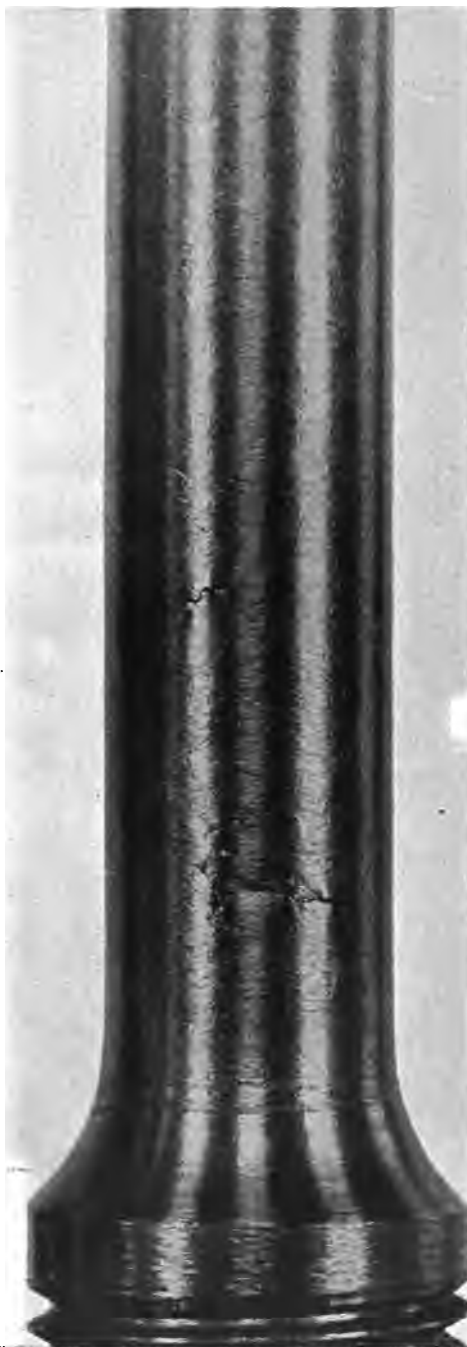
PHOTOGRAPH NO. 45.

Fourteen-inch gun lever test bar specimens showing incipient cracks.

In the fractured ends of the test pieces the metal shows decidedly bright spots, and these are due, it is believed, to the presence of the segregated ferrite. Further, it has been noticed that along the stem of the test pieces incipient cracks are developed, as shown in photograph No. 45. It is highly probable that these incipient fractures are developed in such areas as shown in photograph No. 47, which shows a large ferrite field at the edge of the specimen. It is possible that if the forces are transmitted equally throughout the test piece that such a portion would yield more readily where the carbon was lowest. The strength of such a spot would be approximately that of pure iron, or about 40,000 pounds per square inch, while the darker areas which contain more carbon would show considerably higher values. The presence of much slag in the ferrite areas would also increase the brittleness at this point, and would account for the low ductility in some specimens. Further examples of this form of segregation are shown in photographs Nos. 48 and 49.

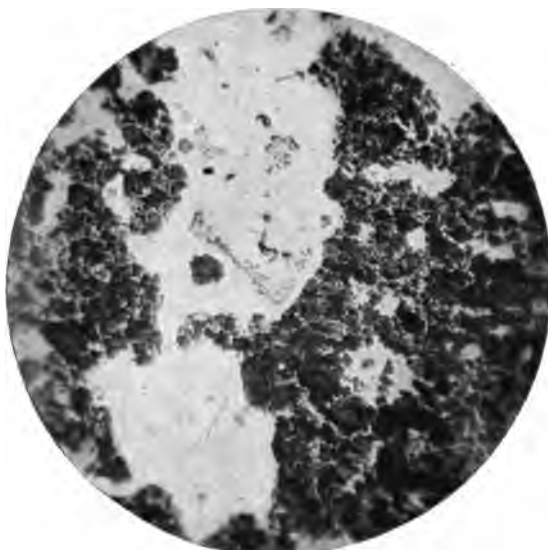
PHOTOGRAPH NO. 48. X50.

Fourteen-inch gun lever. Segregated ferrite (white) with slag inclusions.

This lever was made of cast steel and was broken during the test of the carriage. A microscopic examination revealed the structures shown in photographs Nos. 46 to 51, inclusive.

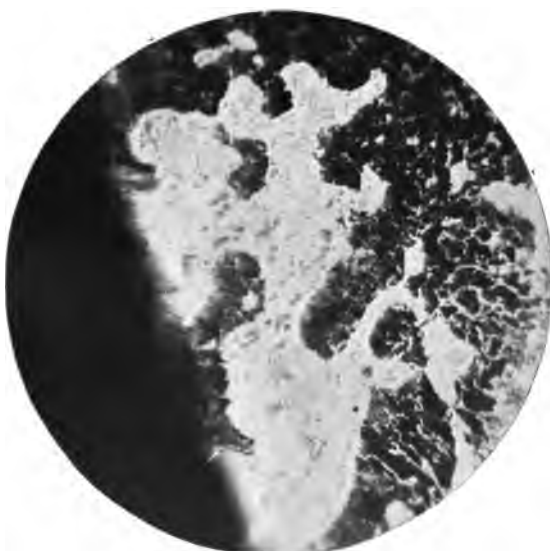
PHOTOGRAPH NO. 47. X50.

Fourteen-inch gun lever. Segregated ferrite on edge of test piece. Slag inclusions.

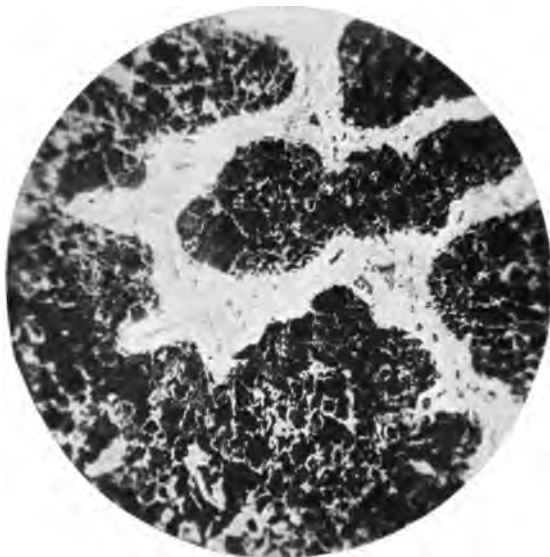
PHOTOGRAPH NO. 48. X50.

Fourteen-inch gun lever. Segregated ferrite (white) with slag inclusions.

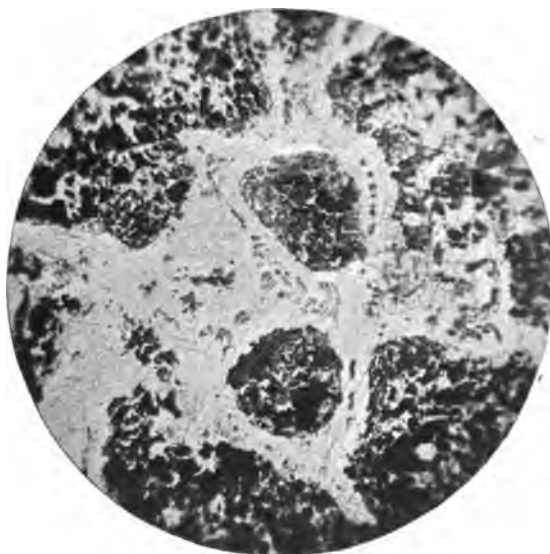
PHOTOGRAPH NO. 49. X50.

Fourteen-inch gun lever. Segregated ferrite with slag inclusions.

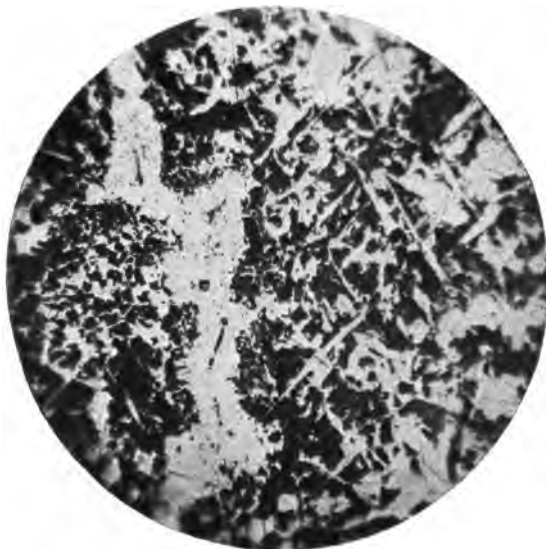
PHOTOGRAPH NO. 50. X50.

Fourteen-inch gun lever. Segregated ferrite and crystalline structure.

The metal has not been annealed in such a way as to remove the original crystallization which took place at the time of solidification. The crystalline structure is shown in photographs Nos. 50 and 51. Proper annealing should have completely wiped out all appearance of this kind. Evidence of this crystalline nature was found in all specimens examined, and it is highly

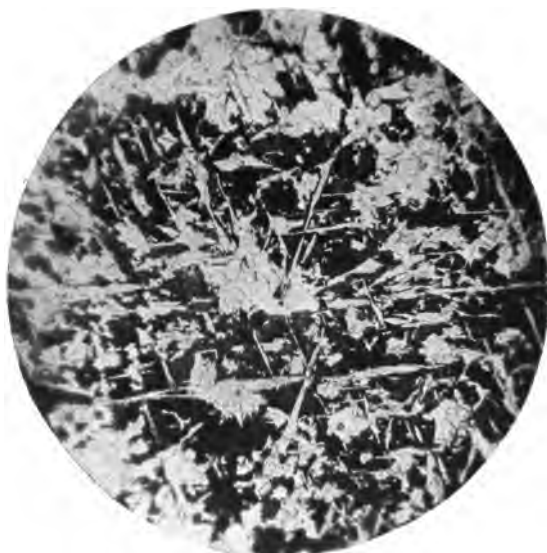
PHOTOGRAPH NO. 51. X50.

Fourteen-inch gun lever. Crystalline structure.

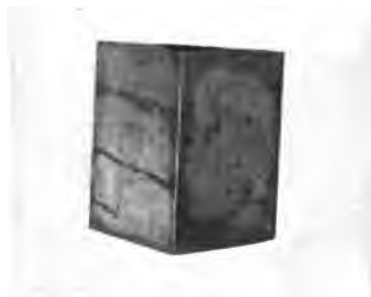
PHOTOGRAPH NO. 52.

Macrostructure of metal removed from 12-inch gun.

A section of the metal 1 inch square was cut from the region of the fracture, and the macrostructure was developed by etching with iodine solution. Photograph No. 52 shows the macrostructure in which is shown several streaks running parallel to the direction of forging on the left-hand face, and on the right-hand face an irregular area of segregation normal to this surface. Small fissures were visible and both faces indicated the presence of slag. Photograph No. 53 shows the microstructure on the longitudinal face in which is seen slag and small fissures. Photographs Nos. 54 and 55 show an unetched and etched area in the longitudinal face, some of the same slag areas being shown in each, and the lack of homogeneity of the metal is evident.
